KINGSTON BRASS

INSTALLATION INSTRUCTIONS

For Use With KB's Twin Handles Bar Faucet

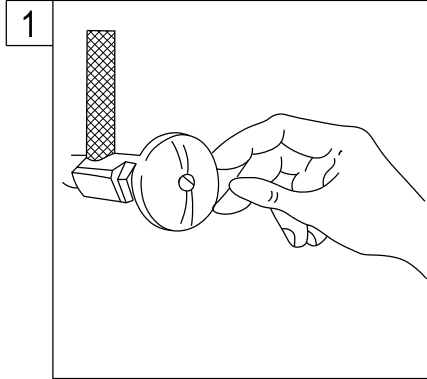
1. Shut off hot and cold water supply under sink. Plug sink drain with cloth to avoid losing small parts. Remove old faucet.

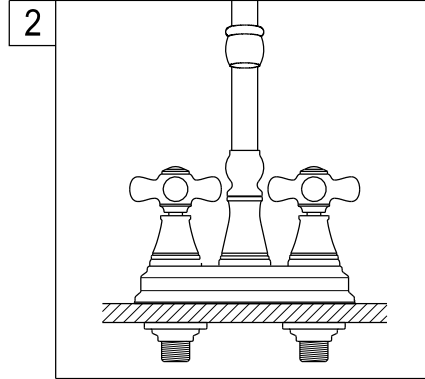
2. Insert the inlet shanks through the sink holes, and press down. Assemble the washers and locknuts on the inlet shanks, and then tighten the nuts by hand.

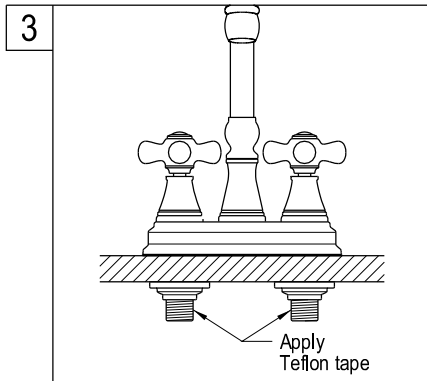
3. Apply Teflon tape to inlet shanks and connect supply lines.

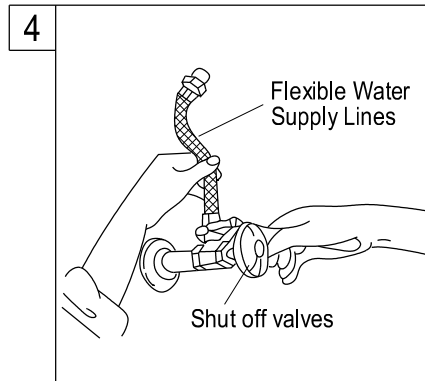
4. Apply Teflon tape to threads on faucet shank and shut off valves, connect water supply line.

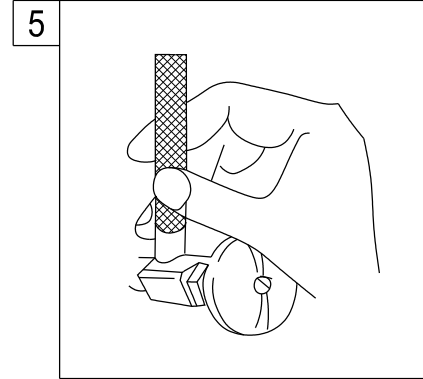
5. Turn on water supply valves and check for leaks, especially all supply line connections.

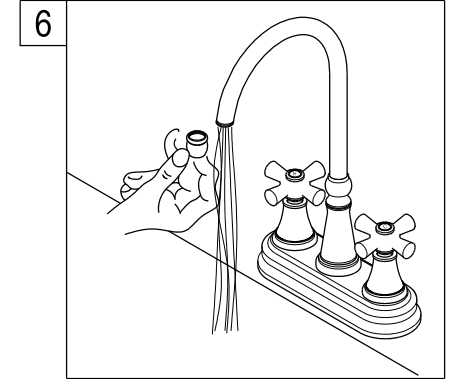
6. Remove aerator and turn on both hot and cold valves, let water run for at least one minute, this will clear any debris left in the line, reinstall aerator.
